**SAS Superstructure**

**Daily Diary Report by Bid Item**

Contract No.: 04-0120F4

**04-0120F4  
04-SF-80-13.2/13.9  
Self-Anchored  
Suspension Bridge****Weather**

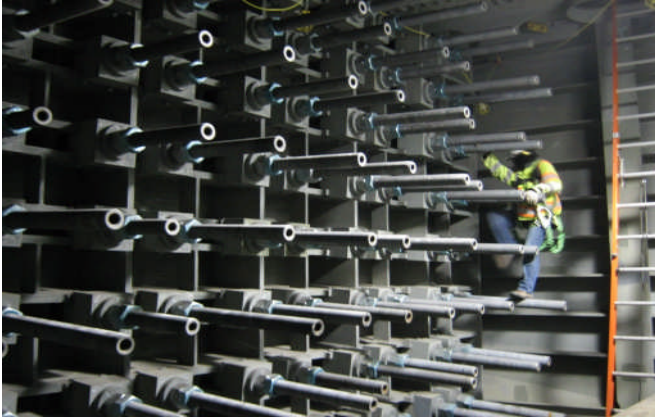
- At 09:15, I arrived back on the bridge.
- From 09:15 until 12:40, Laraine, Abbas, & I inspected the main Cable PWS anchor rods. Each of the rods was checked on the side of the bearing blocks (back side of the anchorage). The following items were checked on each rod at the back side of the anchorage: 1) a visual inspection to see if the bearing nut had separated from the bearing plate washer; 2) a hands on inspection to see if the nuts were loose; & 3) a general visual inspection to look for any damage or rust on the rods. All of the rods appeared OK.

- On the socket side of the PWS anchor rods, we did a visual inspection to make sure that none of the anchor rods were obviously loose. All of the rods were in line with the PWS strand attached to its rod. None of the rods appeared to be sagging or loose.

Inspecting PWS anchor rods
